**SR 166 MP 4.52 Olney Creek (15.0201 0.90):
Preliminary Hydraulic Design Report**

**Beth Rood PE, Project Manager
Certification FPT20-07944
HDR Engineering, Inc.**

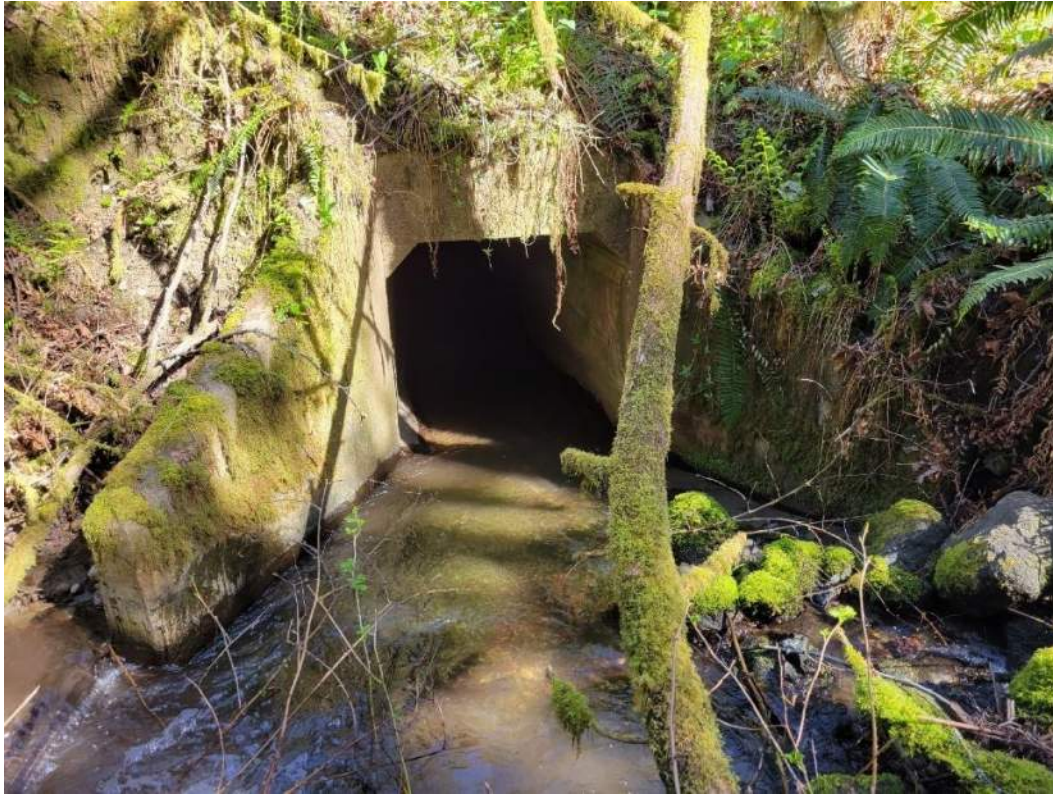
Figure 5: Culvert inlet

The existing structure is a 4-foot-high by 4-foot-wide, four-sided concrete box culvert. The culvert inlet has 20-degree wingwalls, a short headwall, and a bottom apron that extends out as

far as the wingwalls (Figure 5). The culvert outlet has similar characteristics to the inlet except a 20-degree skew toward the right bank and 35-degree wingwalls. The culvert gradient is 2.4 percent and it is perpendicular to SR 166 under approximately 40 feet of fill. The concrete appears to be in good condition. As-built drawings were not obtained for the site. This section summarizes the field report; the full report can be found in Appendix B. Results, locations and photos of the BFW measurements are provided in Section 2.8.2.

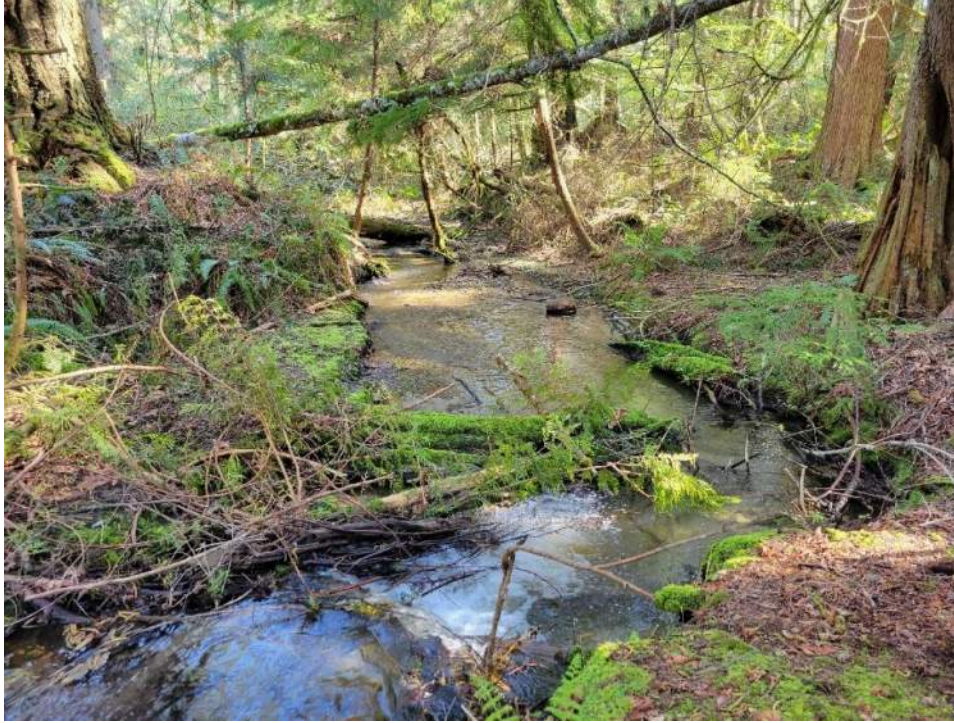
Figure 6: Upstream survey extents looking downstream

The upstream reach is characterized by a riffle pool morphology, meandering planform, abundant large woody material (LWM), and a bed comprising gravel and sand. At the start of the upstream topographic survey limits the flow is immediately directed to the right bank by a channel-spanning log jam (see Figure 6). The flow then widens out to a relatively straight, shallow section with gravel bars along each bank. This is where the first BFW measurement (BFW 1) was taken, as shown in Figure 17. LWM along the left bank then constricts the channel again, which then flows under a channel-spanning log.

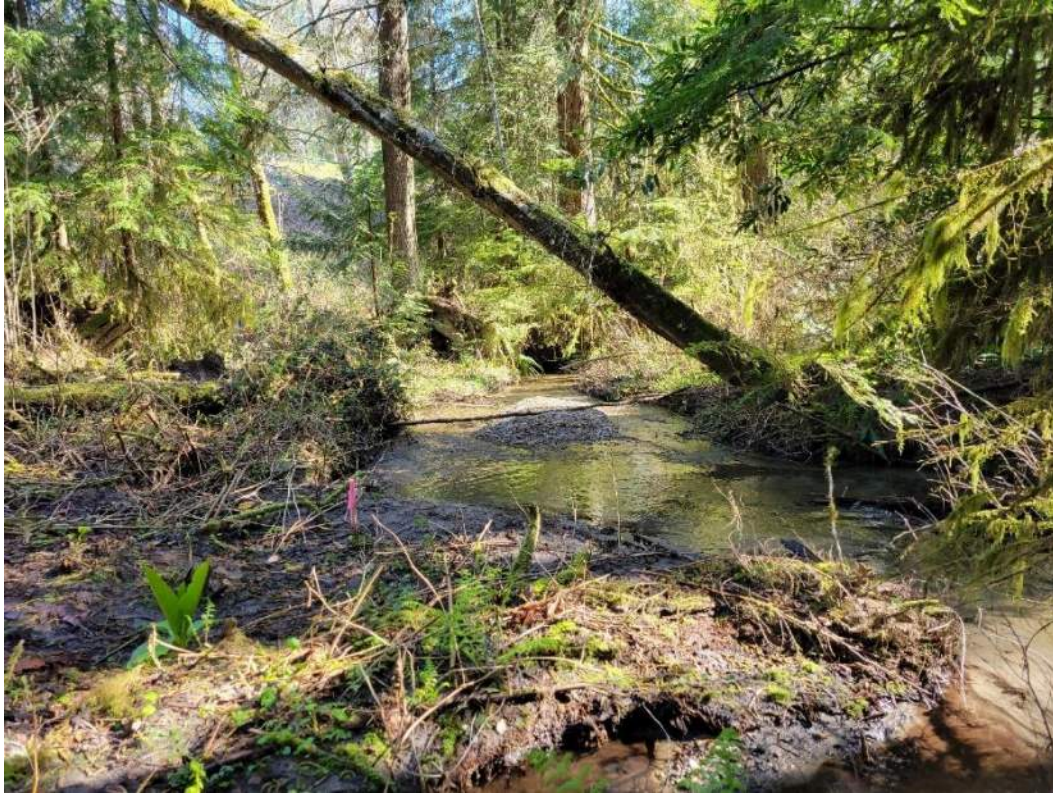
Figure 8: Mid-channel bar looking downstream

Downstream of the reference reach, the channel turns 90 degrees north before straightening out again. LWM on the left bank directs the channel against the right bank and then opens up to a straight section containing a mid-channel bar, shown in Figure 8. A small tributary (Tributary 2) enters the channel along the right bank at the mid-channel bar. This tributary has no known stormwater inputs but has similar features along it as found in Tributary 1 including groundwater seeps, saturated soils, and hydric vegetation. Downstream of the mid-channel bar, the channel narrows and flows under a log bridge formed between two stumps (Figure 9). There is a gravel bar on the left side of the channel under the log bridge.

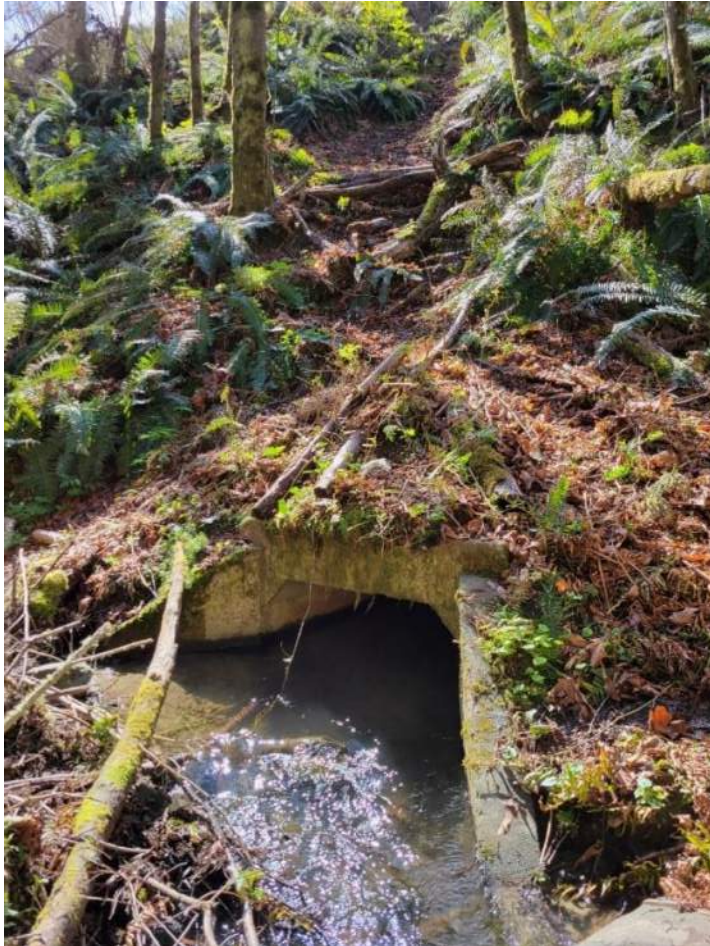
Figure 10: Culvert outlet

The downstream end of the culvert is the same size and material as at the inlet end. The headwall and wingwalls are skewed slightly to the right to direct flows in a more downstream direction. Large angular rock and accumulated woody material at the outlet create backwater within the culvert, so that the culvert was half full of streambed material (Figure 10).

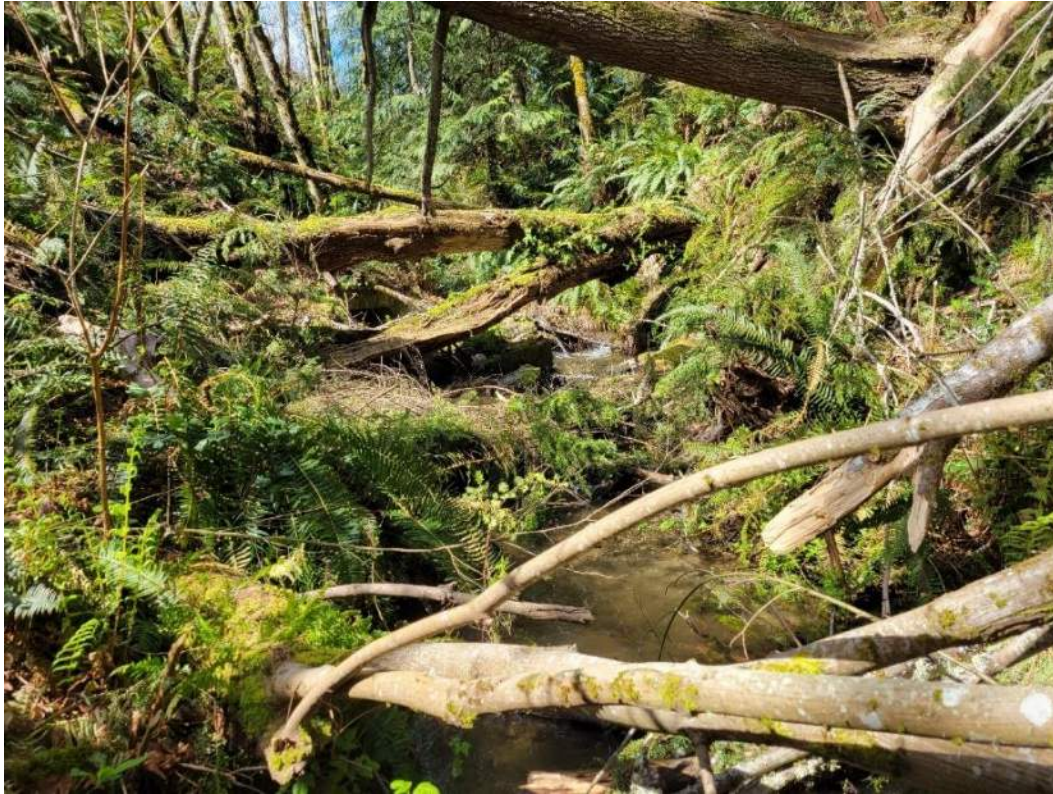
Figure 11: Straightened channel section looking upstream

Immediately downstream of the culvert, the channel travels through a large pool formed by large angular rock and LWM, and then cascades down to a 90-degree bend. The bend to the right approximately 15 feet downstream of the culvert outlet has a moderate amount of bank erosion from the bend near the culvert outlet. The channel then flows parallel to SR 166 for approximately 100 feet. This section is highly confined by the road fill slope on the right bank and steep left bank for the first 50 feet downstream of the culvert inlet. This section contains large downed trees and recently cleared vegetation and far less understory vegetation overall than in the upstream section (Figure 11). There was also some angular rock mixed in with the rounded rock in this section, likely recruited from the road embankment.

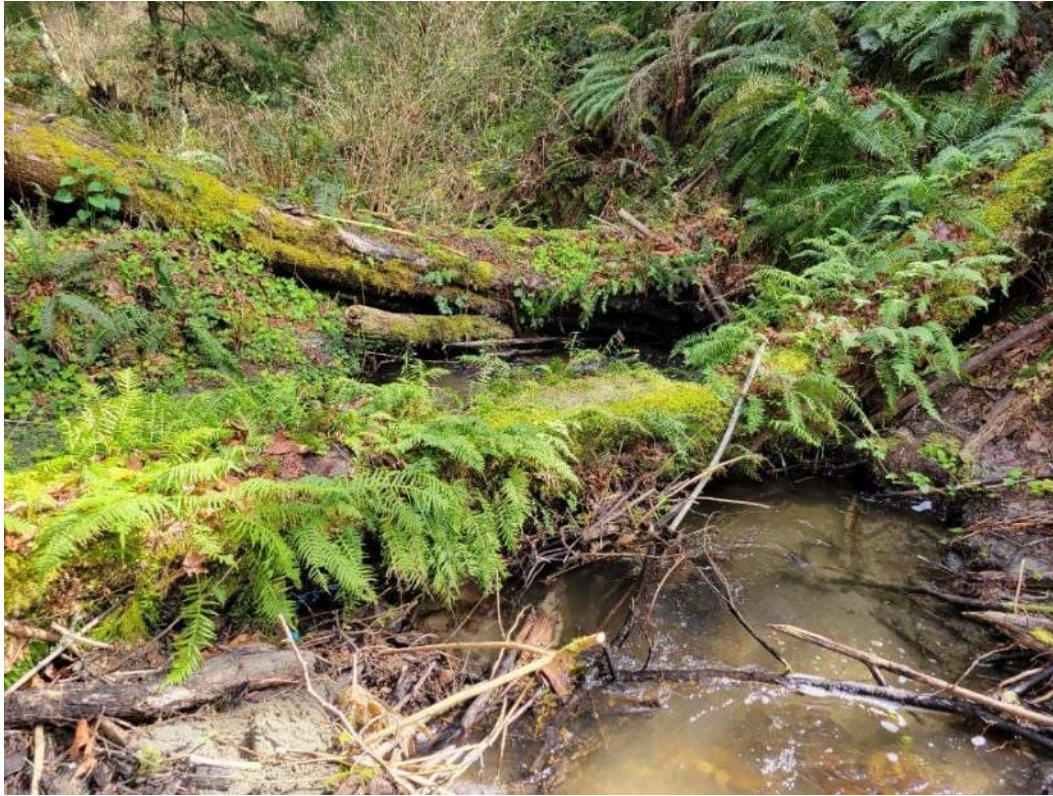
Figure 12: LWM bridges looking downstream

The channel then bends to the left and some potential floodplain access opens on the left. The right bank is steep through this bend and there was minor bank undercutting. As the channel straightens out two approximately 3-foot-diameter logs are spaced 10 feet apart across the channel. The water surface was at or within approximately 6 inches (in) of the bottom of the logs and the channel width was narrowed through the section. At high flow events these two logs likely create backwater as flow is forced under them (Figure 12).

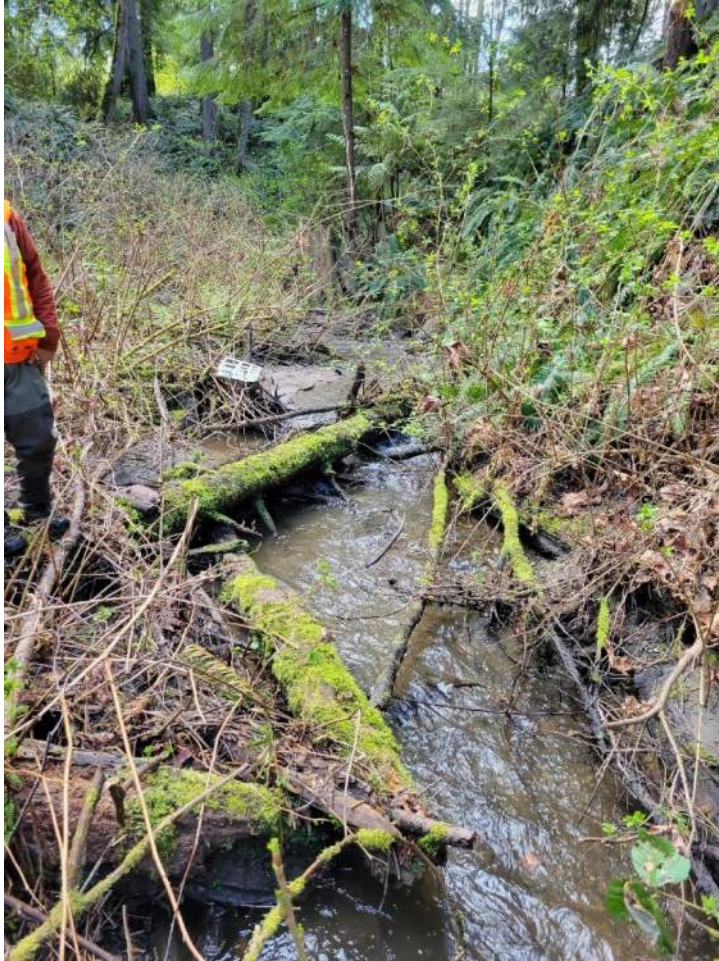
Figure 13: LWM creating small drops and pools

Downstream of the BFW 3 measurement, a long parallel piece of LWM along the right bank diverts flow to the left side of the channel. There is fine sediment deposited behind the log and a point bar on the inside of the bend. There is also a marked increase in understory vegetation in this section. Farther downstream, within about 25 feet a large log on the left bank diverts flow back to the right. Within this section there are multiple pieces of LWM spanning and running lengthwise along the channel, resulting in small water surface drops and forming deep pools (Figure 13).

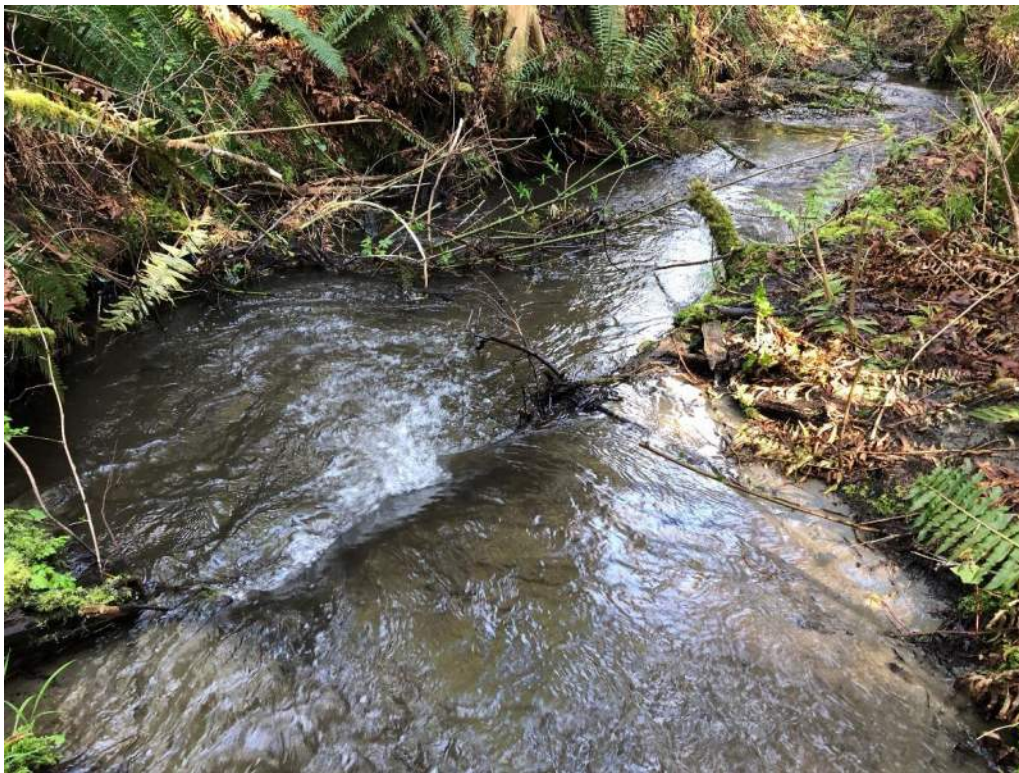
Figure 14: Logs in the streambed formed short water surface drops in the upstream reach

LWM was present within the stream channel and banks throughout the upstream reach. There were 12 pieces of LWM in and across the channel within the surveyed reach, including three places where logs in the streambed formed short water surface drops (Figure 14). The LWM ranged from approximately 8 to 18 inches in diameter and a large cedar stump was present on the right bank near the downstream end of the reach that created a scour pool (Figure 9 above). The presence of LWM throughout the stream channel provides habitat complexity and cover for salmonids using this reach for rearing and migration during high flow periods. These functions are limited during summer low flows where shallow water and LWM debris jams can impede fish movement through this reach. Returning Coho Salmon often gather at the mouths of streams and wait for the water flow to rise, such as after a rainstorm, before heading upstream. The higher flows and deeper water enable the fish to pass obstacles, such as logs across the stream or beaver dams that would otherwise be impassable. The abundant LWM provides good cover and habitat complexity for rearing salmonids throughout the upstream reach.

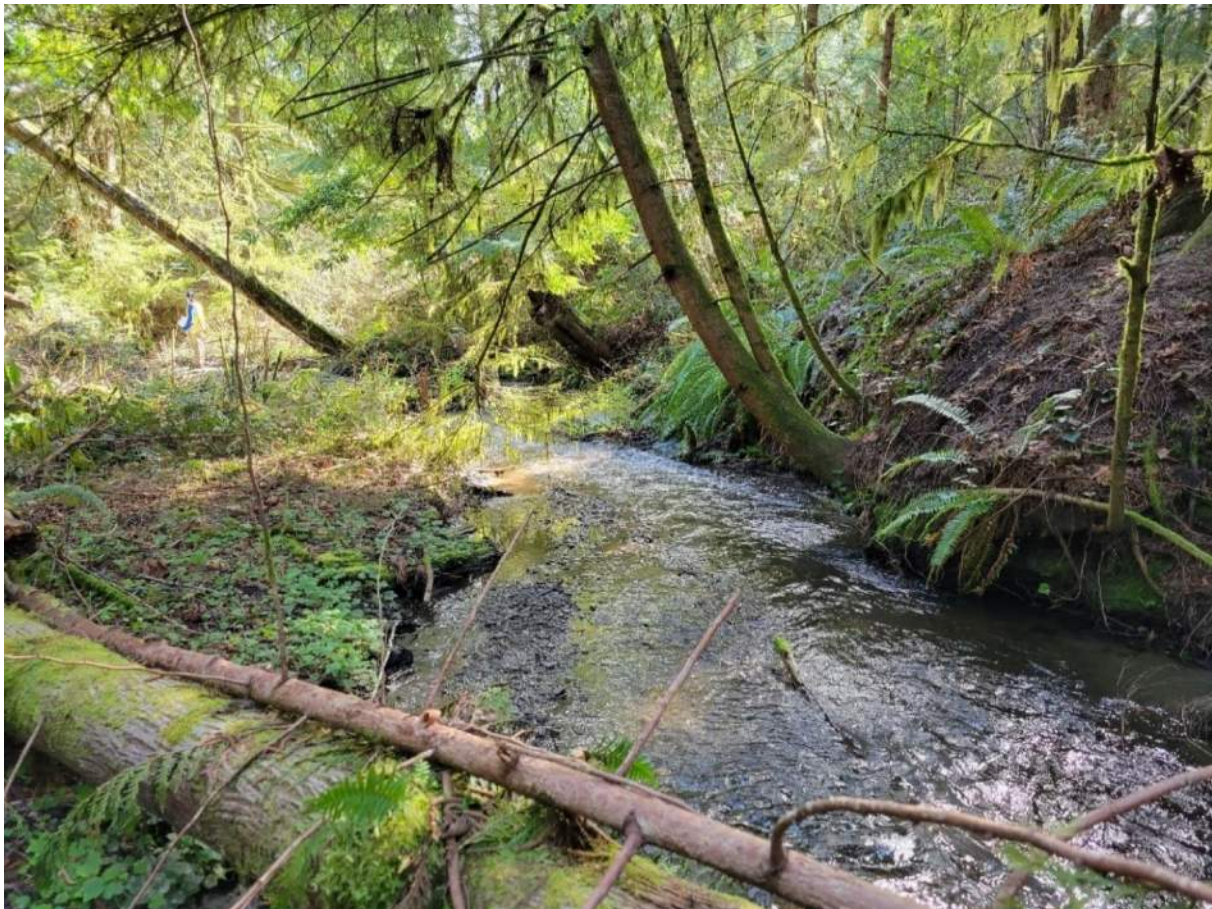
Figure 15: Photo of upstream reference reach, looking downstream

A section of stream approximately 175 feet upstream of the culvert (Figure 15) was chosen as the reference reach because it appears to be most representative of a naturally occurring streambed with the least amount of anthropogenic influences. This reach has an average channel gradient of 1.5 percent. Further upstream within the survey limits and immediately upstream of the culvert the channel is confined. A pebble count was conducted within the reference reach; results are summarized in Section 2.8.3. Figure 16 shows the locations of the reference reach, BFW measurements, and pebble counts. This reference reach was used for proposed design channel shape and to compare the existing channel to proposed hydraulic results throughout this Preliminary Hydraulic Design (PHD) Report. The downstream reference reach, shown in Figure 20, had a narrower BFW measurement, confined FUR, and steeper channel slope of 2.4 percent, which agrees with the prevailing longitudinal slope discussed in Section 2.8.4.

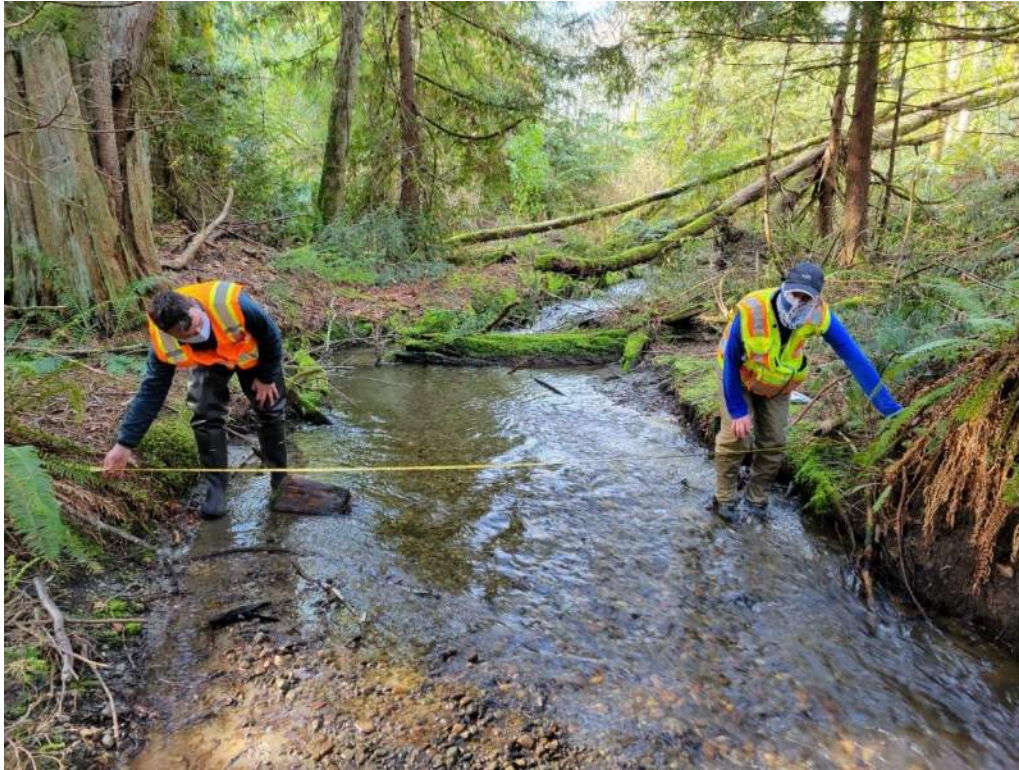
Figure 17: BFW 1 measurement location facing upstream

During the site visit performed on April 5, 2021, four BFWs were measured in the field, two upstream of the crossing and two downstream. The BFWs ranged from 11.3 to 14.5 feet. Figure 17, Figure 18, Figure 19, and Figure 20 show the stream conditions where all BFWs were measured, and Figure 16 shows the overall location where these BFWs were measured. A BFW concurrence meeting with HDR, WSDOT, WDFW, and the tribes was conducted on September 22, 2021. An additional bankfull width measurement was taken downstream of the crossing and a previously taken measurement was revised. Table 3 summarizes BFW measurements collected and whether they were included in the design average. The design average BFW is 13.2 feet.

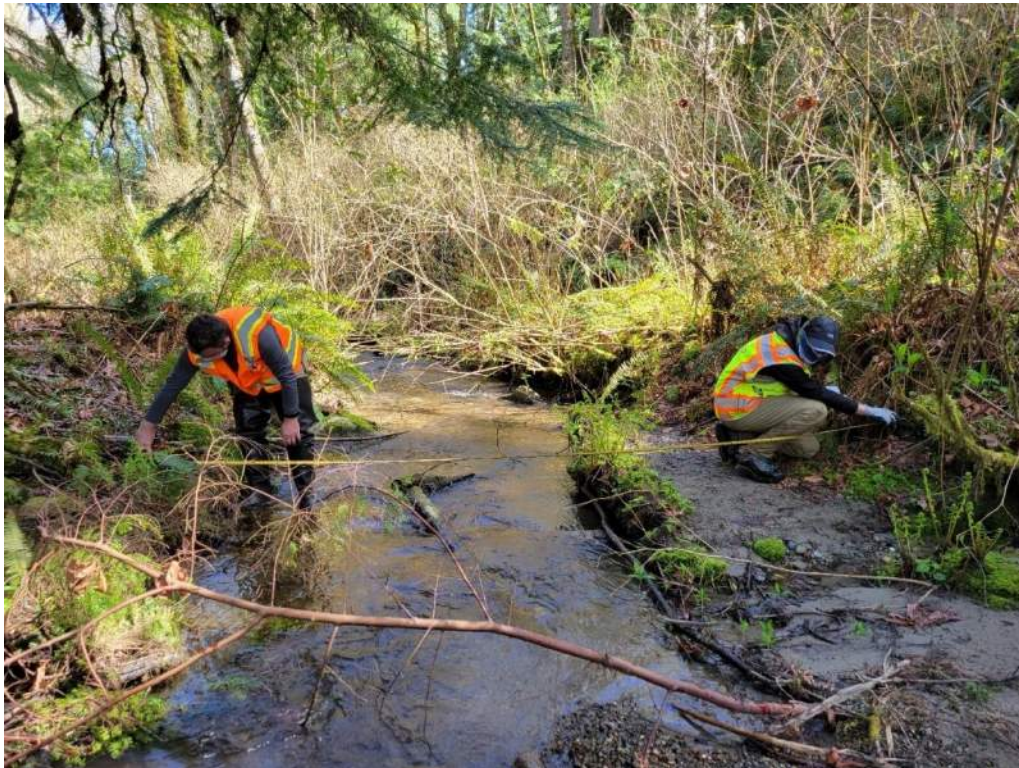
Figure 19: BFW 3 measurement location facing downstream

Downstream of the logs the channel returns to its more typical section seen upstream of the crossing with abundant LWM complexity, and has floodplain access above both banks. The channel width is initially constricted by an LWM piece along the right bank, and then it widens downstream. Fine-grained sediment is deposited behind an LWM piece positioned parallel along the right bank. This is where BFW 3 was taken (Figure 19).

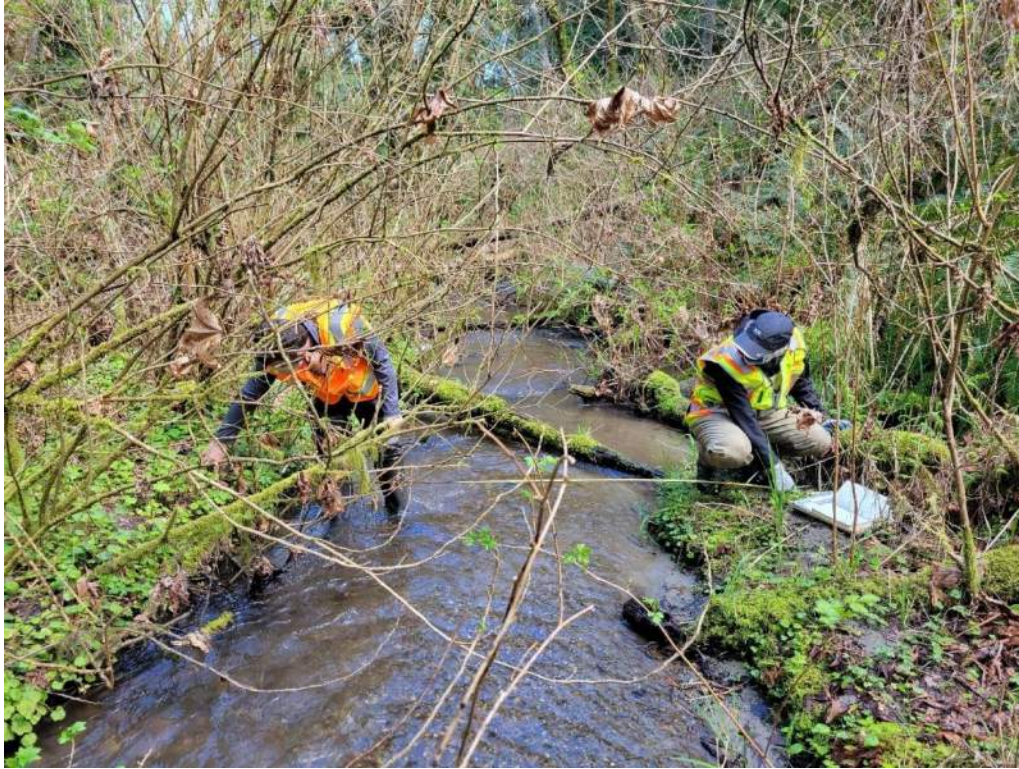
Figure 20: BFW 4 measurement location facing downstream

The channel then straightens out for a short section and increases in slope, which carries through and beyond the downstream topographic and reconnaissance survey extents. BFW 4 was taken just upstream of the topographic survey limits (Figure 20). This was also the location of the downstream reference reach and where the second pebble count took place. The largest natural particle size observed in the downstream reach was 5 inches.

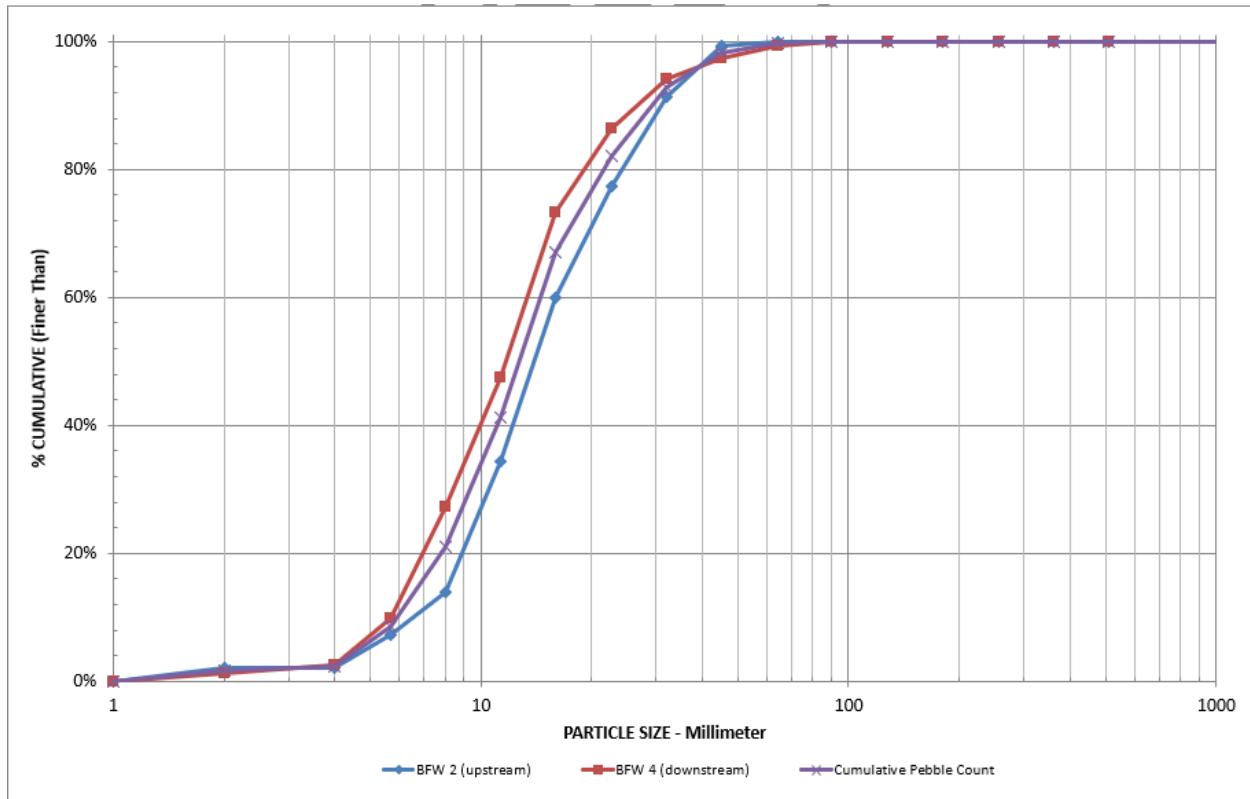
Figure 22: Sediment size distribution in the reference reach

Two pebble counts, each of about 150 particles, were performed within the reference reaches, one upstream and one downstream of the crossing (Figure 16). Two pebble counts were considered adequate since the material throughout the reach was consistent visually and clearly smaller than the streambed substrate specification material to be proposed. The cumulative distribution and specific pebble sediment sizes are provided in Figure 22 and Table 4. Material consists primarily of fine to coarse gravels. Only one small cobble was observed in the downstream reference reach, but several were observed outside the reference reach including the largest material observed, which was approximately 5 inches in diameter. Figure 23 shows a photo of the typical material found throughout the upstream reach and Figure 24 shows the largest observed material throughout the project reach.

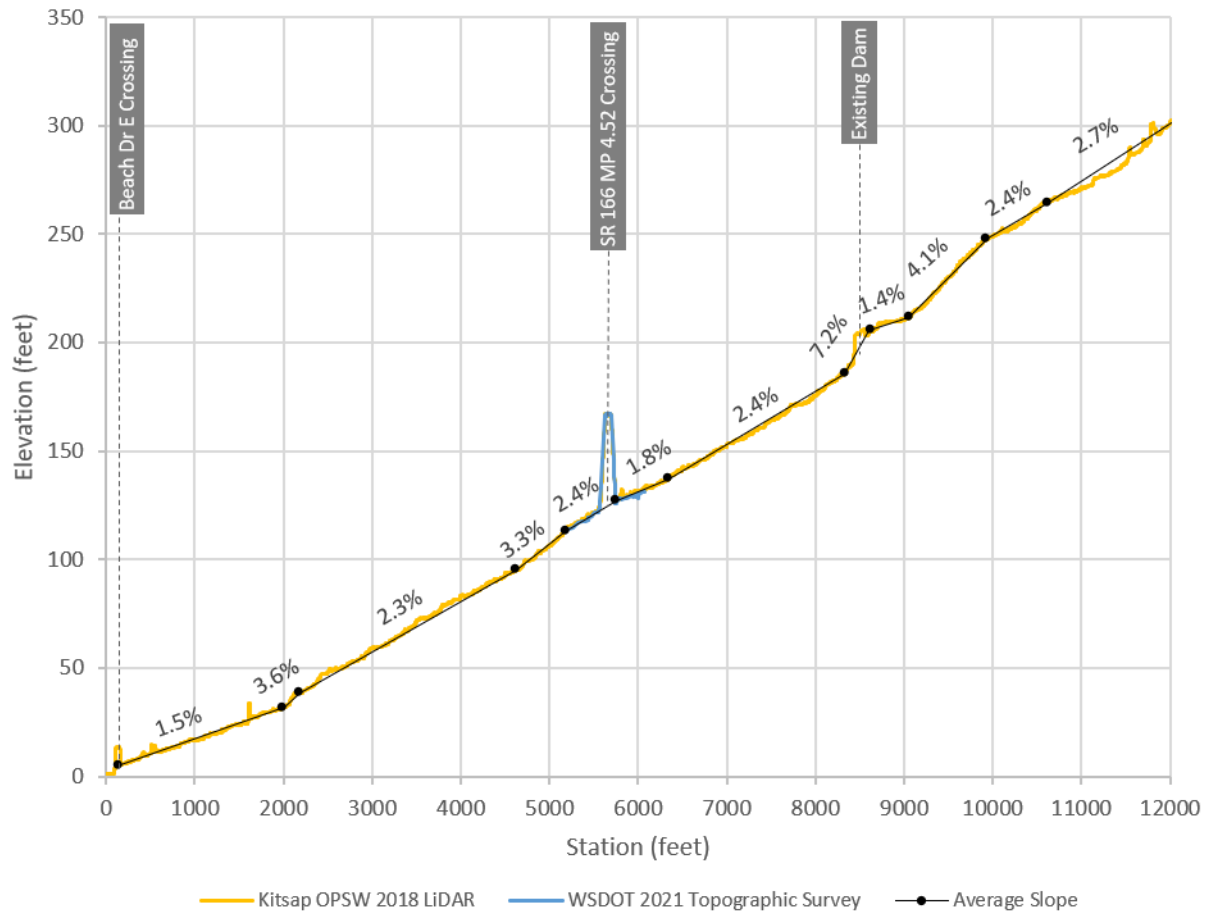
Figure 25: Watershed-scale longitudinal profile

The overall average slope of the channel is 2.4 percent based on the data presented in Figure 25. Based on average reach slopes described above, the location of the project site on the long profile of Olney Creek seems to be perched when considering the prevailing channel slopes upstream and downstream of the crossing. This finding may indicate a potential for future long-term degradation at the project site. See Section 8.2 for discussion of long-term degradation potential. As the design progress, analysis of long-term degradation should be revisited.

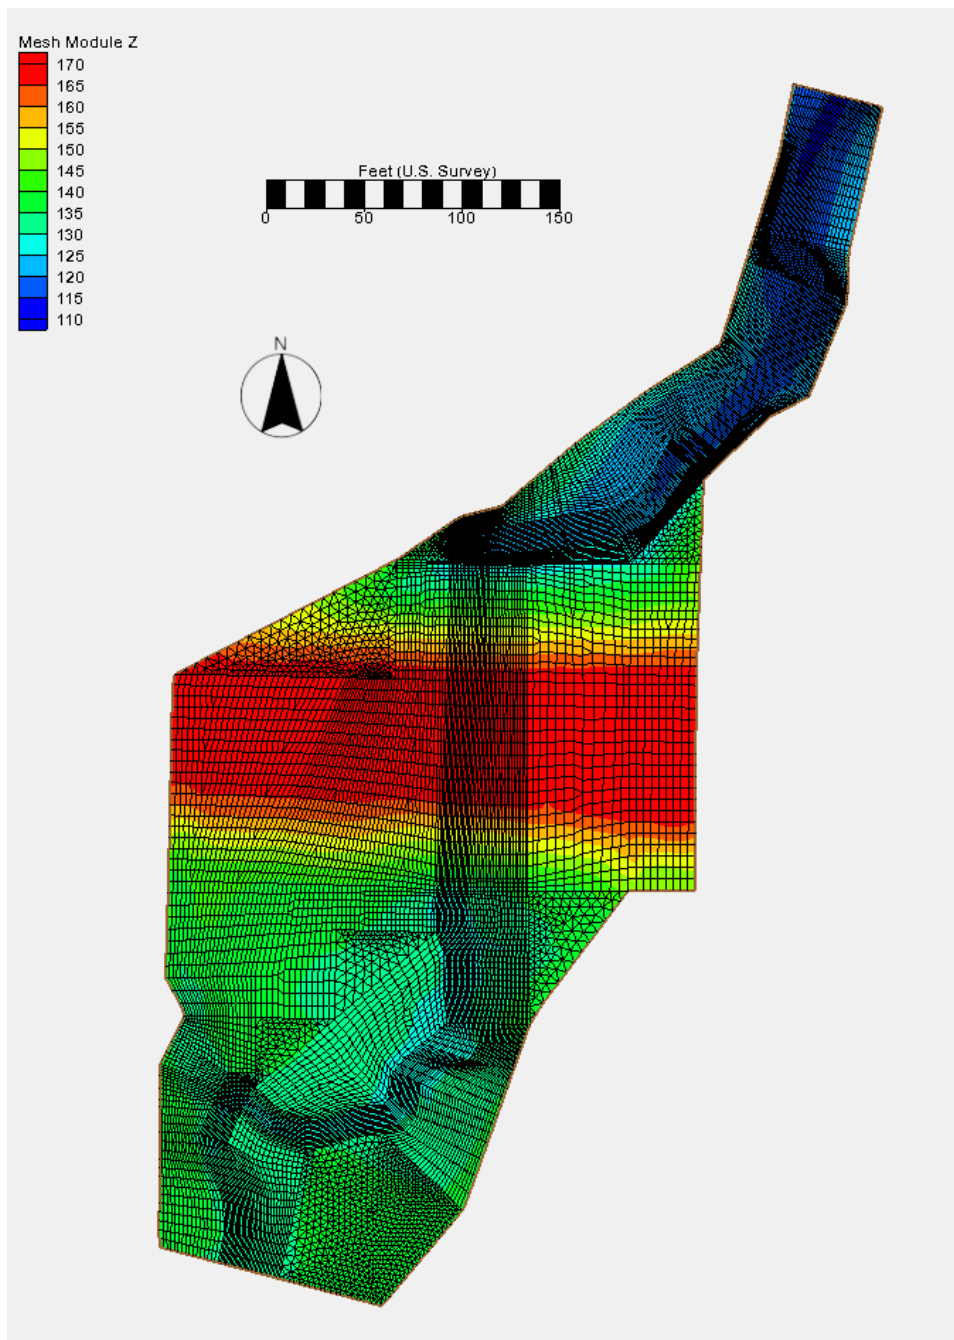
Figure 28: Existing-conditions computational mesh with underlying terrain

The hydraulic model upstream and downstream extents start and end within the topographic survey data. The detailed survey data are stitched into the LiDAR to incorporate more area adjacent to the channel. The model boundary starts approximately 160 feet upstream of the existing culvert inlet and ends approximately 210 feet downstream of the existing culvert outlet, measured along the channel centerline. The computational mesh elements are a combination of patched (quadrilateral) and paved (triangular) elements, with finer resolution in the channel and larger elements in the floodplain. The existing mesh covers a total area of 94,377 square feet (SF), with 14,938 quadrilateral and 3,054 triangular elements (Figure 28). Natural conditions have a mesh that covers a total area of 94,377 SF, with 30,057 quadrilateral and 5,583 triangular elements (Figure 29). The proposed mesh covers a total area of 89,738 SF, with 26,186 quadrilateral and 5,566 triangular elements (Figure 30).

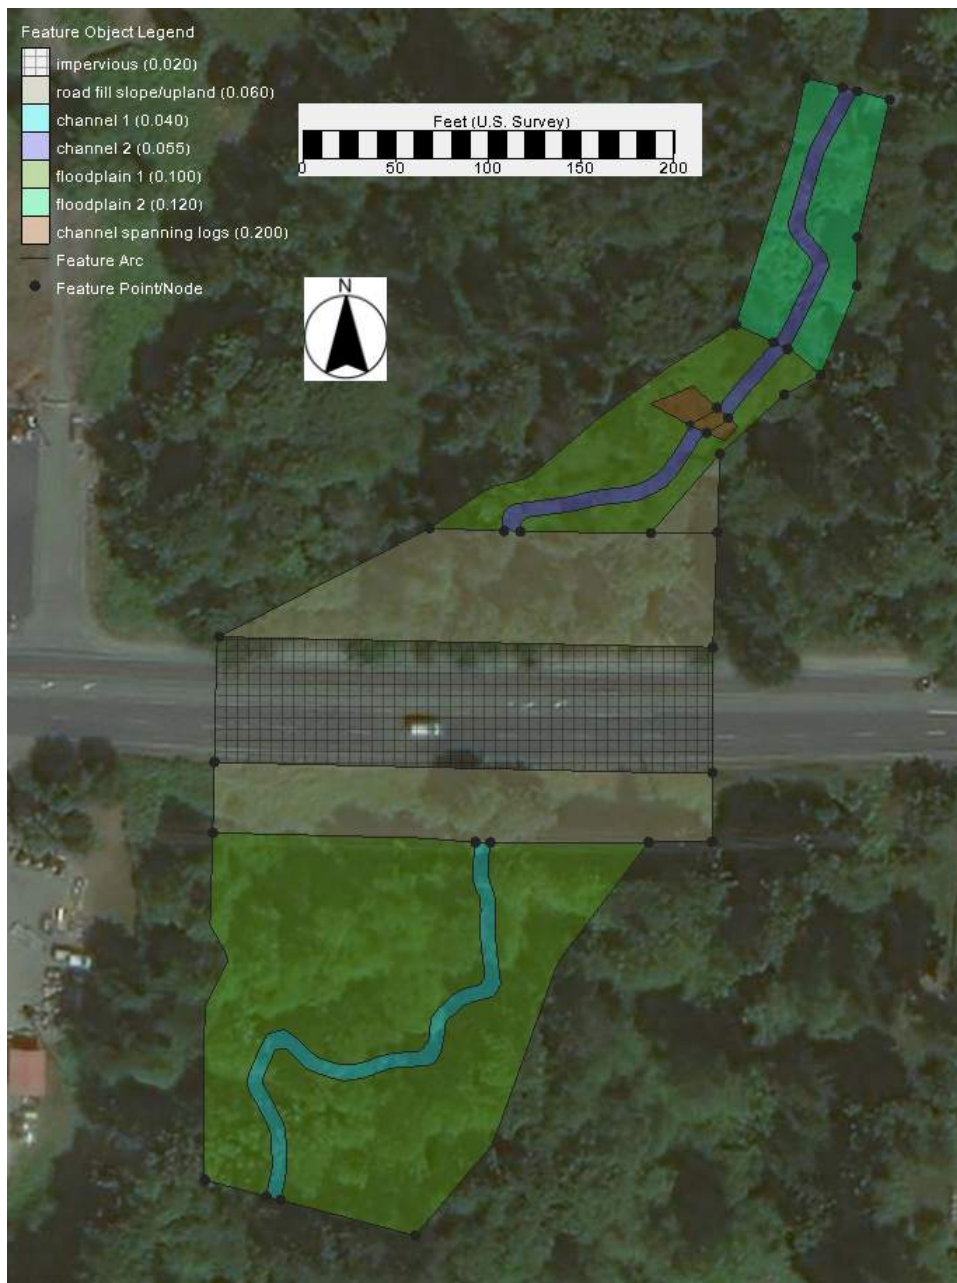
Figure 31: Spatial distribution of existing-conditions roughness values in SRH-2D model

.100 and the lower half of the downstream reach was assigned a value of 0.120. A short section in the downstream reach (near STA 3+10) was assigned a roughness value of 0.20 because of two large channel-spanning wood pieces that partially block flow above water depths of approximately 1 foot. The proposed channel was assigned a roughness value of 0.055 and the proposed floodplain was assigned a roughness value of 0.10. See Figure 31, Figure 32, and Figure 33 for a spatial distribution of hydraulic roughness coefficient values for existing-conditions, natural-conditions, and proposed-conditions, respectively.

Land cover type	Manning's n
Impervious	0.020
Road fill slope/upland	0.060
Channel 1	0.040
Channel 2	0.055
Floodplain 1	0.100
Floodplain 2	0.120
Channel-spanning logs	0.200
Proposed channel	0.055

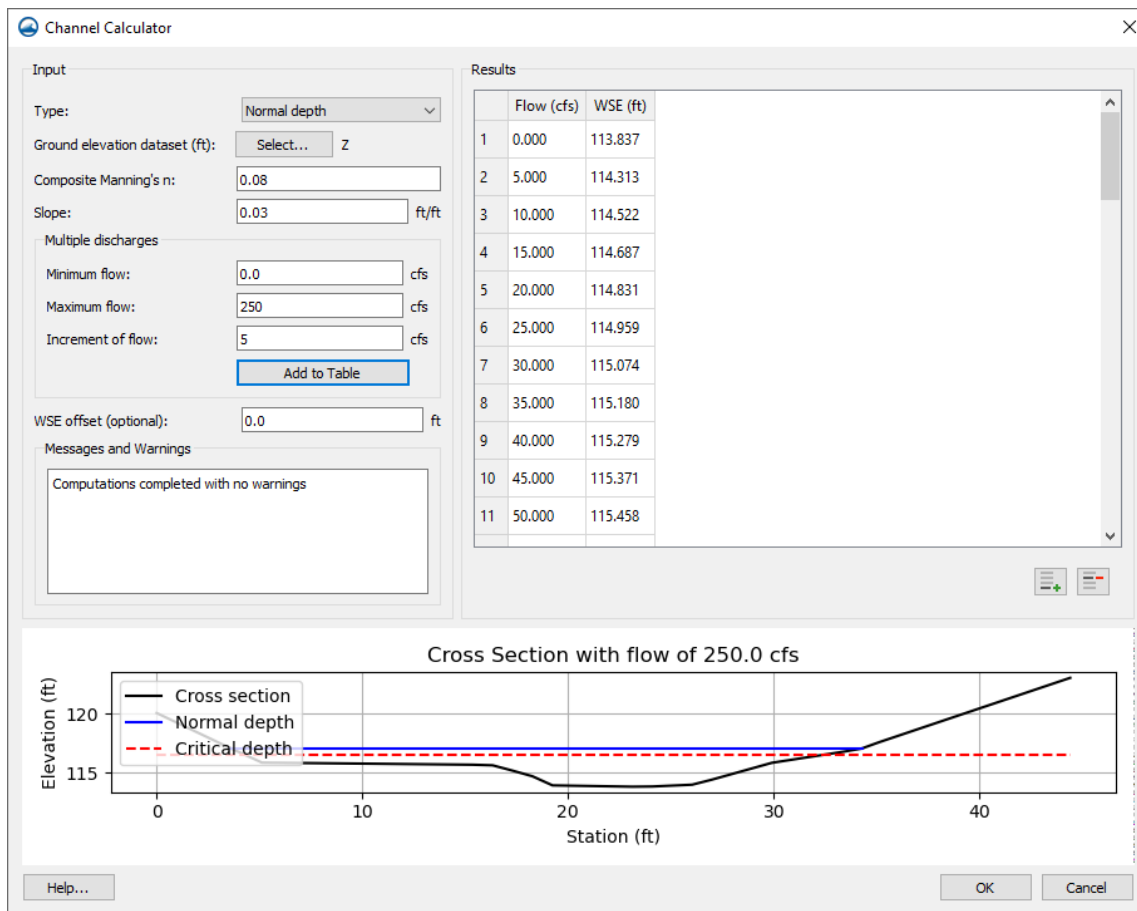
Figure 34: Downstream normal depth rating curve for Exit H for all boundary conditions

I to those presented in Section 3 for each of the peak discharges modeled. The downstream normal depth boundary condition rating curve was developed within SMS using the existing terrain, assuming a downstream slope of 3 percent based on local survey data and a composite roughness of 0.080 (see Figure 34). A boundary sensitivity analysis was done with slopes varying between 2.8 and 3.2 percent with a constant roughness value. The varying boundary conditions result in water surface elevations (WSELs) that converge outside the extents of the proposed channel grading.

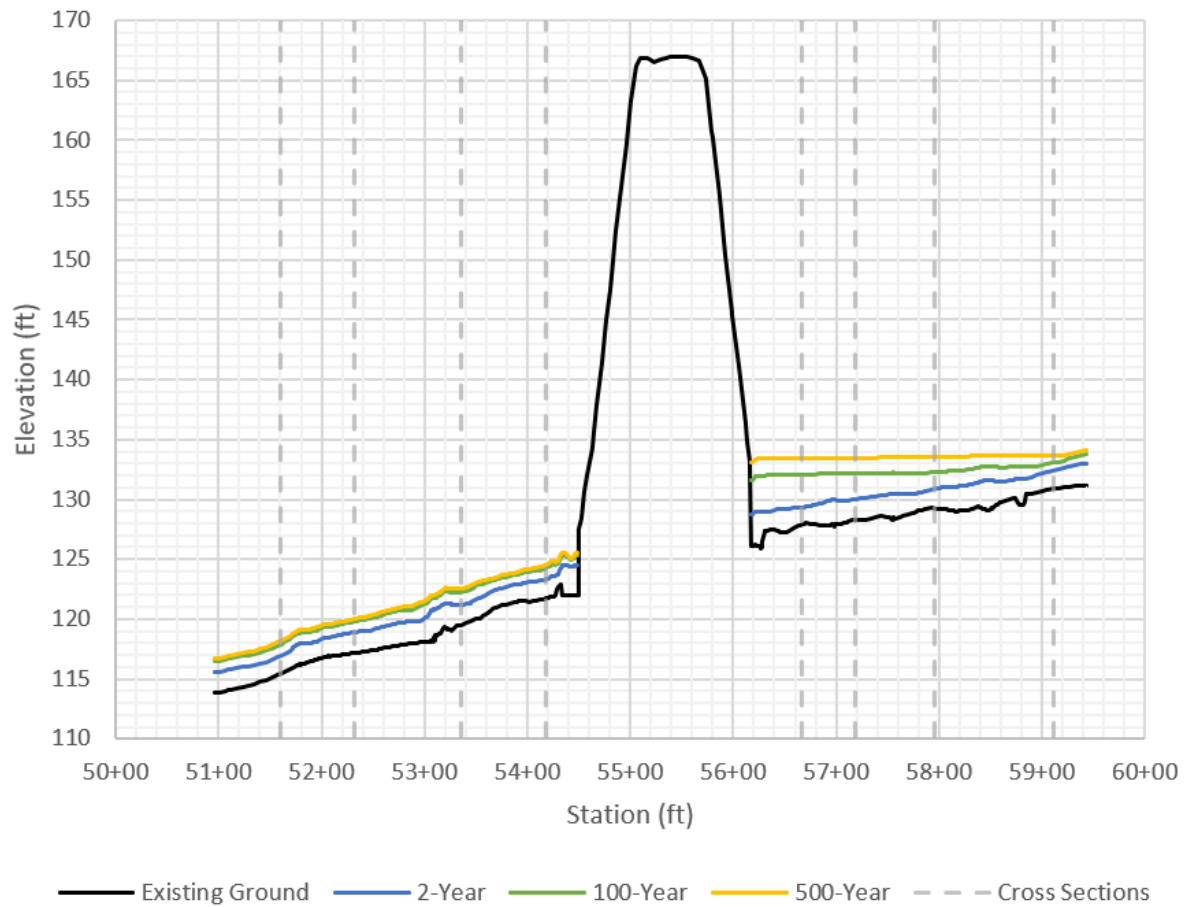
Figure 41: Existing-conditions water surface profiles

The culvert backwater affects results for the 100-year and 500-year flows for nearly the entire upstream reach. In the upstream reaches velocities range from 2.92 ft/s during the 2-year event to 5.23 ft/s for the 100-year event. In the downstream reaches, average channel velocities range from 2.7 ft/s during the 2-year event to 6.32 ft/s during the 100-year event. Floodplain and main channel velocities are also summarized in Table 8. Shear values in the upstream reach range from 0.60 pound per square foot (lb/SF) during the 2-year event to 2.05 lb/SF during the 100-year event. Shear values on the downstream reach range from 1.08 lb/SF at the 2-year event to 3.88 lb/SF during the 500-year event. The largest velocities occur at the culvert outlet (Figure 43). For the 2-year flow upstream of the culvert backwater effect, the depths range from 1.53 to 1.60 feet. Depths in the downstream reach range from 1.44 feet at the 2-year event to 3.73 feet during the 500-year event.

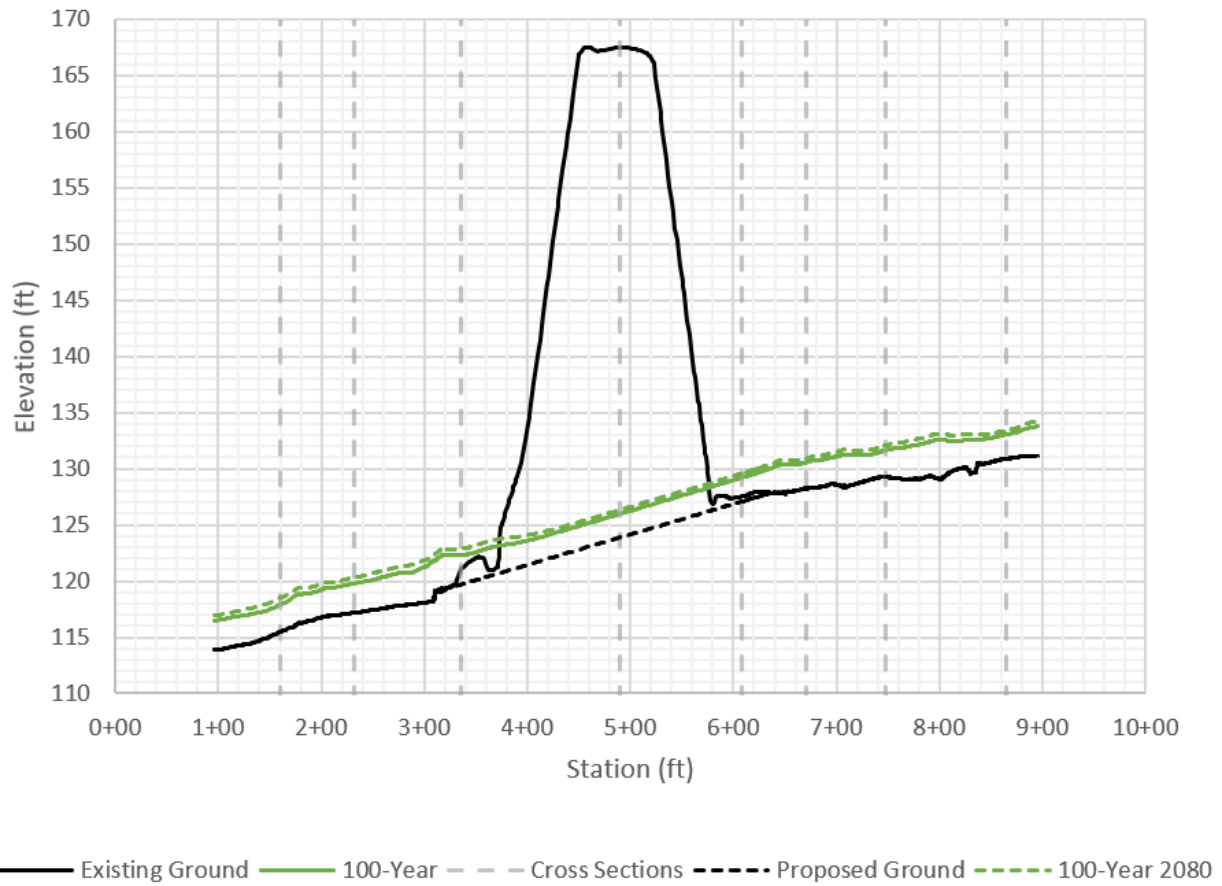
Figure 46: Natural-conditions water surface profiles

Upstream of the crossing, velocities range from 4.11 ft/s to 5.28 ft/s during the 100-year event and 4.52 ft/s to 6.00 ft/s during the projected 2080 100-year event. In the downstream reaches, average channel velocities range from 4.01 ft/s to 5.40 ft/s during the 100-year event and from 4.72 ft/s to 5.75 ft/s during the projected 2080 100-year event. Floodplain and main channel velocities are also summarized in Table 10. Shear values in the upstream reach range from 1.17 lb/SF during the 100-year event to 2.94 lb/SF during the projected 2080 100-year event. Shear values on the downstream reach range from 2.01 lb/SF at the 100-year event to 3.69 lb/SF during the projected 2080 100-year event. The largest velocities occur at the most upstream reach at STA 8+65 (Figure 48). Upstream the depths range from 2.12 feet during the 100-year event to 2.82 feet during the projected 2080 100-year event. Depths in the downstream reach range from 2.43 feet at the 100-year event to 3.17 feet during the projected 2080 100-year event. There is no backwater at the crossing under natural or proposed conditions.
